Building Information - Firelands Local SD (48157) - South Amherst Middle School

Program Type	Assessment Only
Setting	Rural
Assessment Name	South Amherst Middle School-Firelands Local School District
Assessment Date	2004-11-15
Cost Set:	2012
Building Name	South Amherst Middle School
Building IRN	33126
Building Address	152 W Main St
Building City	South Amherst
Building Zipcode	44001
Building Phone	440-986-7021
Acreage	22.50
Current Grades:	5-8
Teaching Stations	46
Number of Floors	3
Student Capacity	560
Current Enrollment	676
Enrollment Date	2004-11-15
Enrollment Date is the date in which the current enrollment was taken.	
Number of Classrooms	39
Historical Register	NO
Building's Principal	Mr. Tony Reeser
Building Type	Middle

Building Construction Information - Firelands Local SD (48157) - South Amherst Middle School (33126)

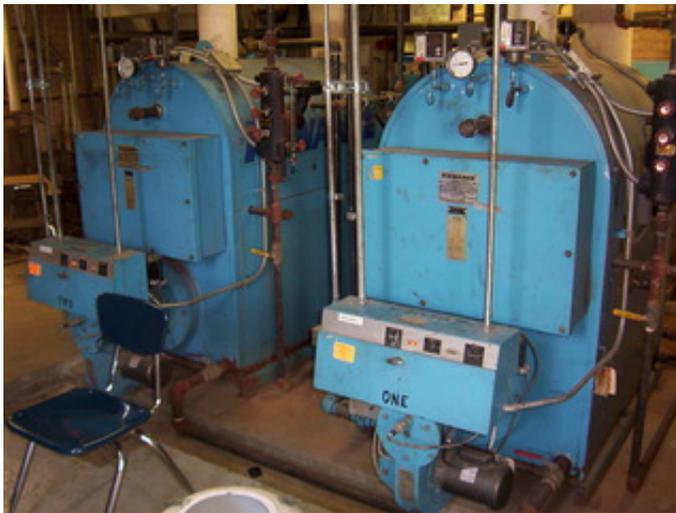
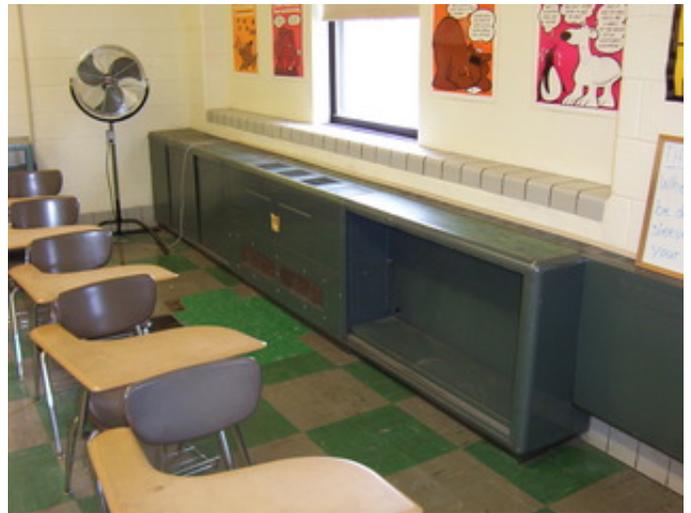
Description: The boiler is located in the original building's basement and is a gas-fired steam unit. It was installed in 1991. Steam is piped to certain areas of the building. In a nearby area, some of this steam is converted to hot water which heats the remainder of the building. There is no ductwork available. The media center is served by an above ceiling unit that provides heat and air conditioning. The condensor is mounted on the exterior face of the north wall. The 1974 gym and locker rooms are served by a separate heating/ventilating unit. A few offices have window air conditioners. In the 1963 annex heating is provided by piping underneath the concrete floor. However there is supplemental forced air (via ductwork) provided. Each room has its own thermostat to provide some control of temperature. The boiler is a gas fired hot water unit and there is no air conditioning.

Rating: 3 Needs Replacement

Recommendations: In both buildings, the entire HVAC system needs to be replaced. The original building's boiler is an older unit and there is no direct control provided. Ductwork needs to be provided as well. In the annex, the unit is also an older system and better control is needed. Air conditioning is also required.

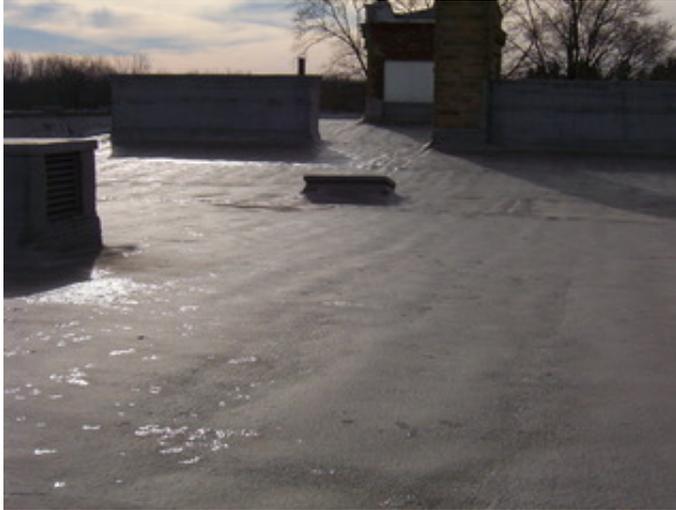
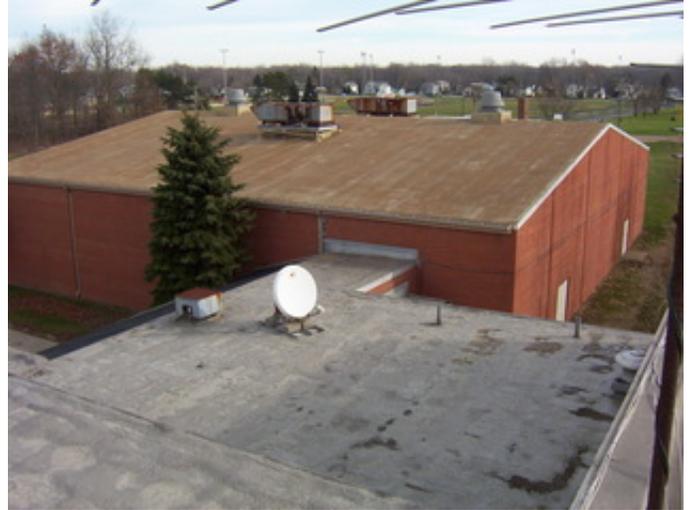
Rating: 3 Needs Replacement

Recommendations: Provide for all new membrane roofs that meet the requirements of OSDM.

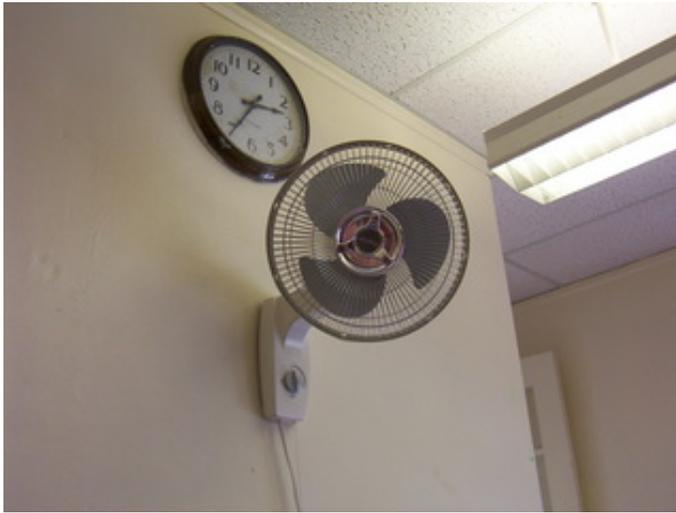
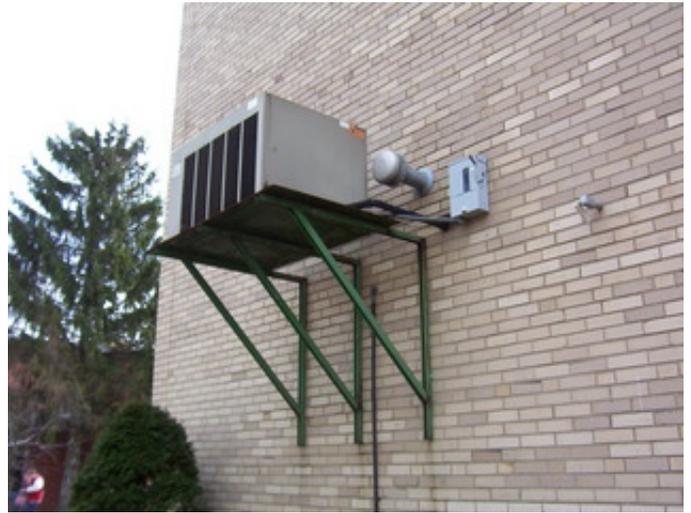
C. Ventilation / Air Conditioning

Description: A few window air conditioners are used in season and removed in colder weather. The media center has its own electric furnace that provides some cooling.

Recommendations: Full central air conditioning is required. Costs for it are contained in plate A: HVAC.

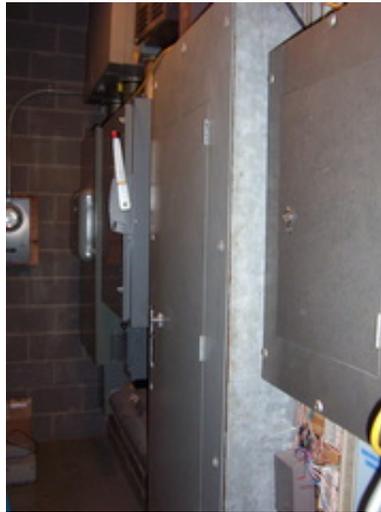
D. Electrical Systems

Description: 1000 amps of power were located in a utility closet in the 1957 addition. Some of this equipment was fairly new. A 400 amp panel was located near the 1974 gym addition. A 400 amp panel was noted in the 1963 annex building.

Rating: 3 Needs Replacement

Recommendations: Provide for a complete upgrade for the entire building due primarily to the age of the equipment and due to the need for the air conditioning system.

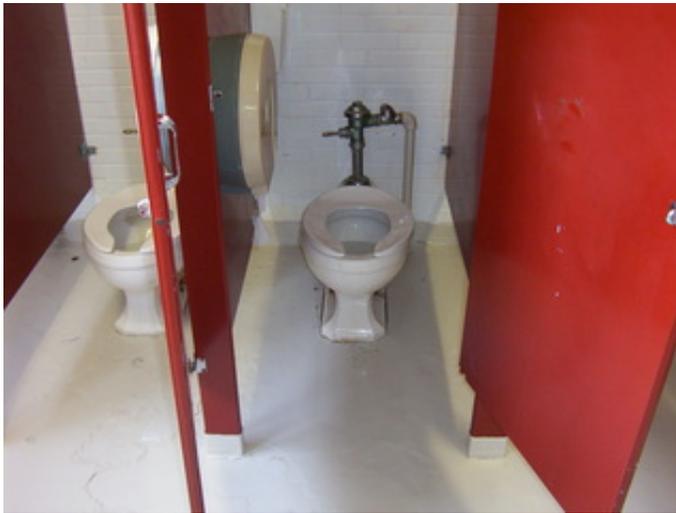
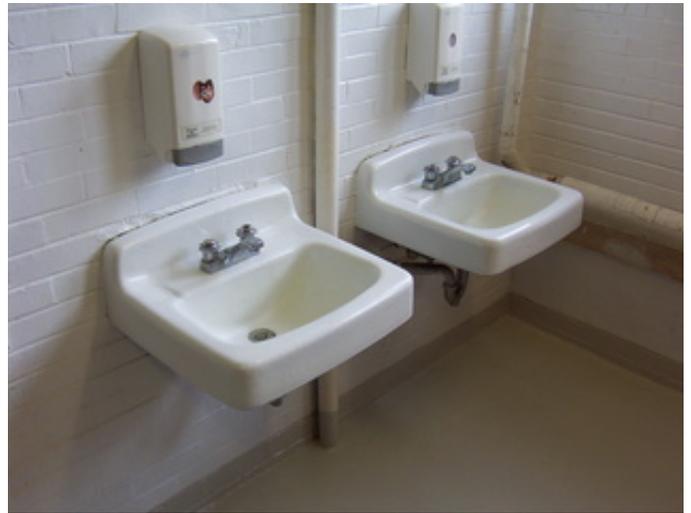
E. Plumbing and Fixtures

Description: The buildings contain both floor and wall mounted units. Galvanized piping was noted in the older portions of the building. No backflow preventer could be located in the annex building.

Rating: 3 Needs Replacement

Recommendations: Provide for the items noted below to bring the buildings up to date.

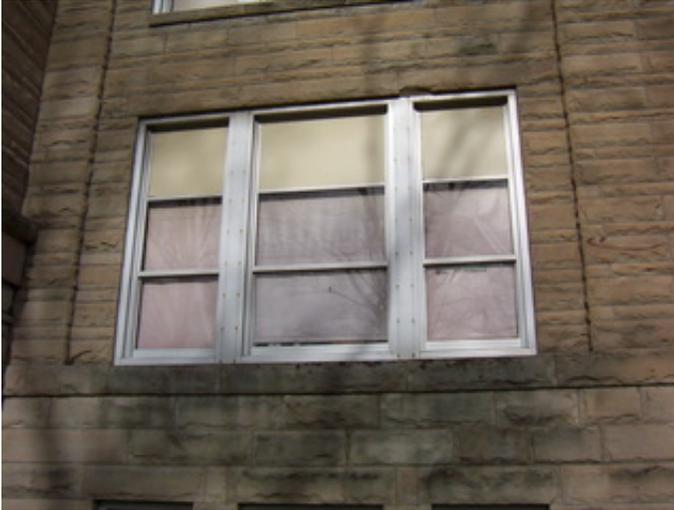
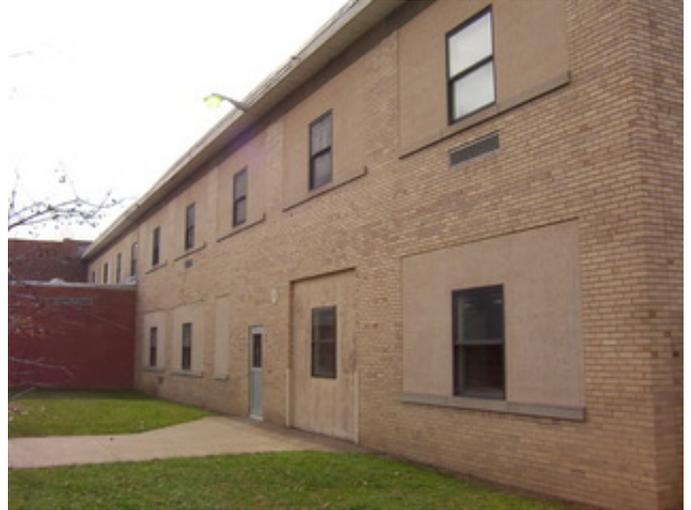
F. Windows

Description: All windows were noted as being single glazed units. None had integral blinds.

Rating: 3 Needs Replacement

Recommendations: Provide for all new windows throughout the building.

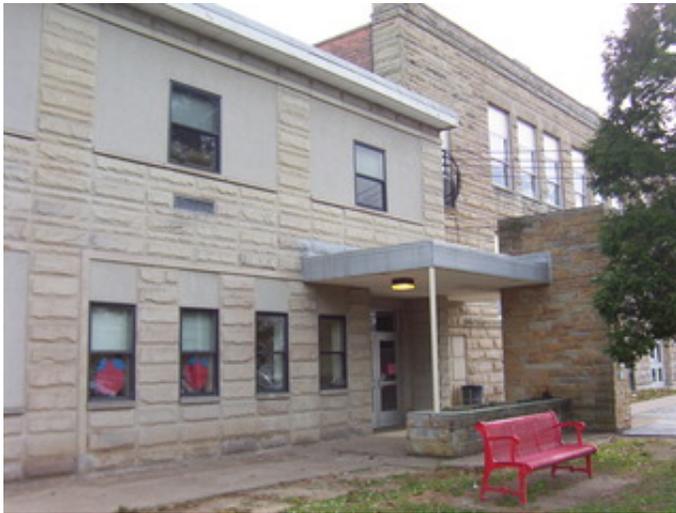
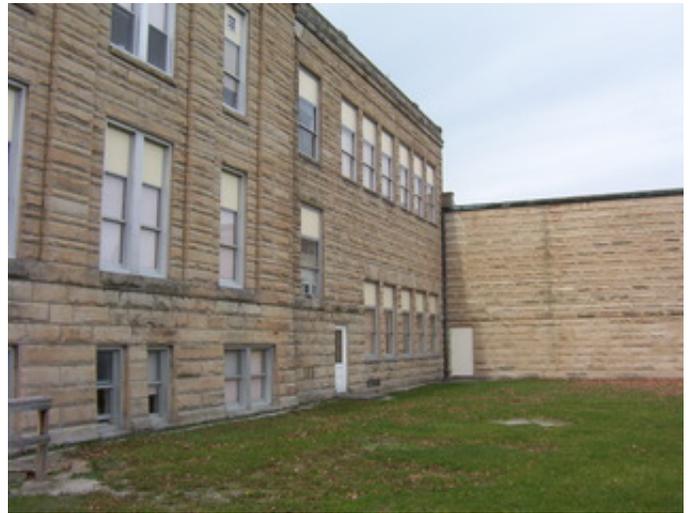
Description: The original building and the first three additions were built with stone provided from a nearby quarry. This stone appeared to be in very good condition.

Rating: 2 Needs Repair

Recommendations: Provide for minor tuckpointing, caulking, cleaning, and sealing of the noted masonry surfaces.

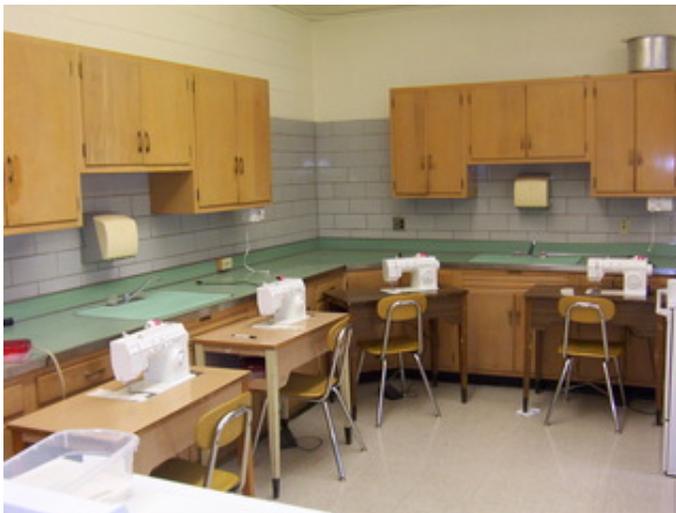
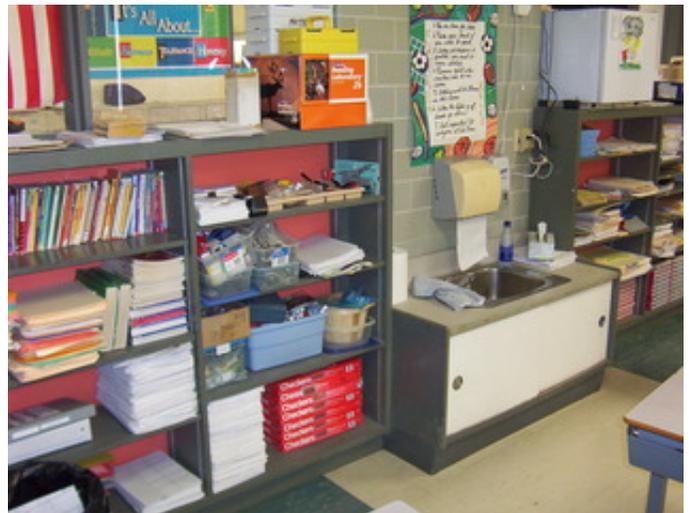
Description: The overall condition of the casework and finishes was noted as being in a satisfactory condition. However, once unit ventilators are removed, new ductwork installed and new sprinklers are added, a full upgrade will be required. The two gym floors also need to be screened and coated. All kitchen equipment was noted as being greater than ten years of age. Lockers in the 1974 portion date to its construction.

Rating: 3 Needs Replacement

Recommendations: Provide for a full upgrade to all casework and finishes and for a complete kitchen upgrade. Sand and recoat both gym floors.

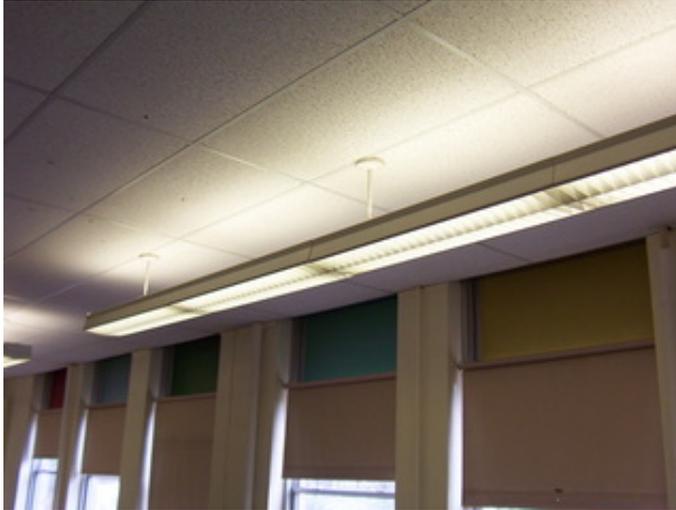
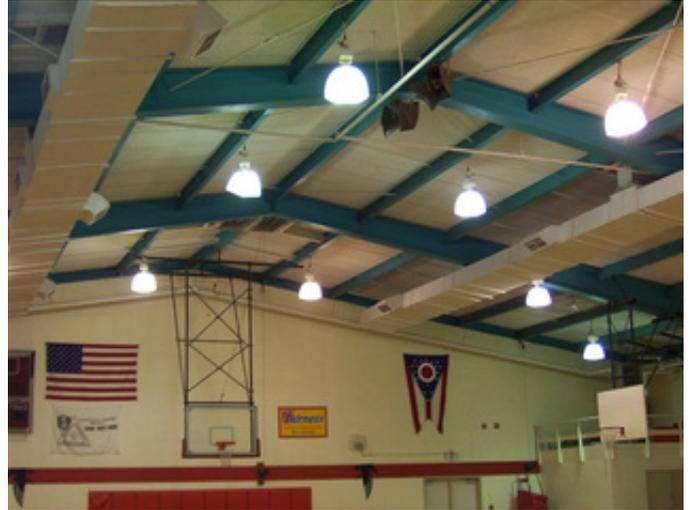
Rating: 3 Needs Replacement

Recommendations: Provide all new dual level lighting throughout the building due to the need to add sprinklers and ductwork.

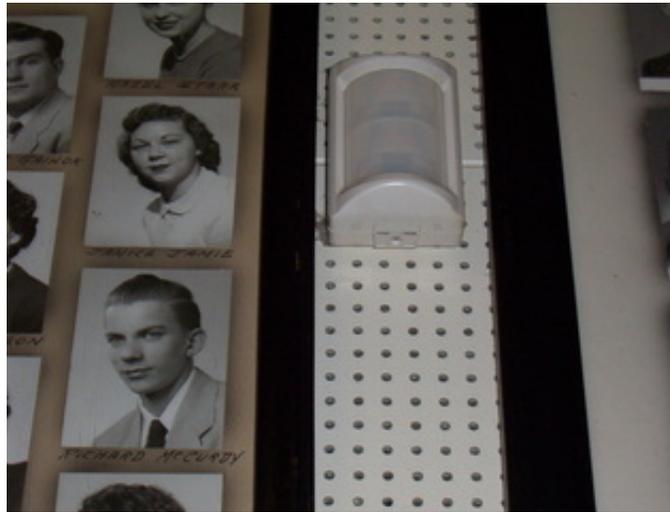
Rating: 3 Needs Replacement

Recommendations: Provide for a full security system upgrade and improved site lighting.

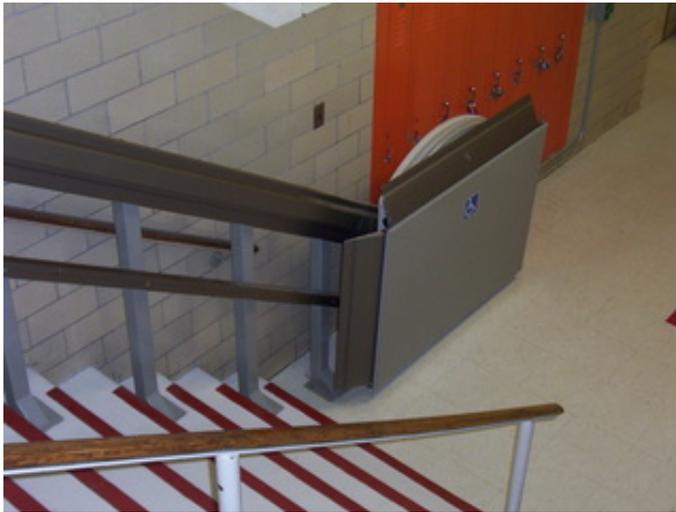
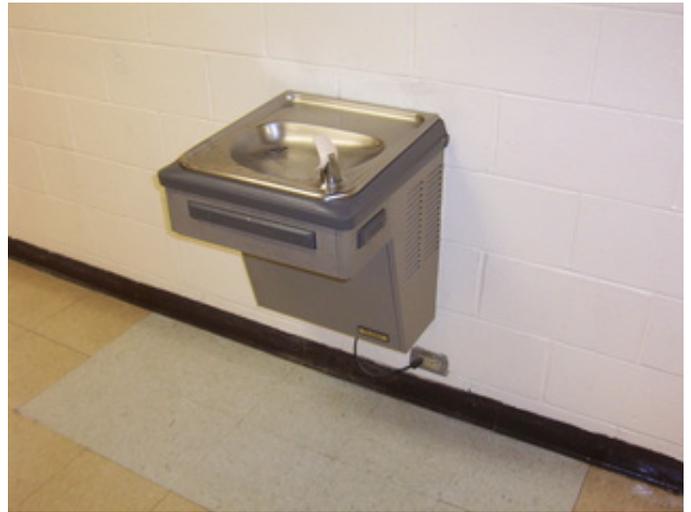
O. Handicapped Access

Rating: 2 Needs Repair

Recommendations: Provide for the work shown below to allow for full accessibility.

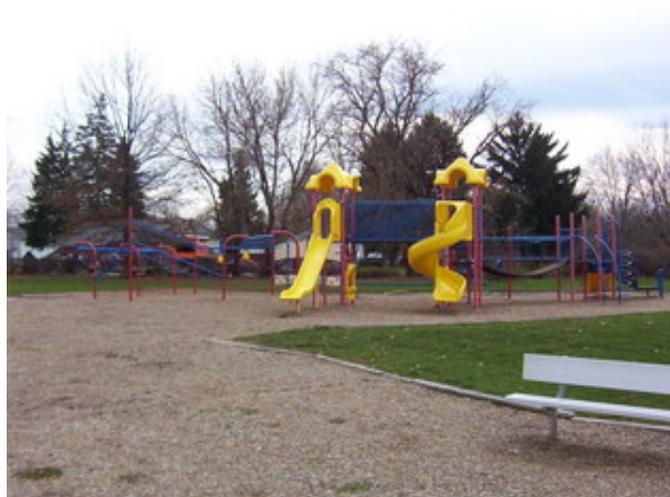
P. Site Condition

Rating: 3 Needs Replacement

Recommendations: Provide for the work noted below to bring the site up to conditions required by the OSDM.

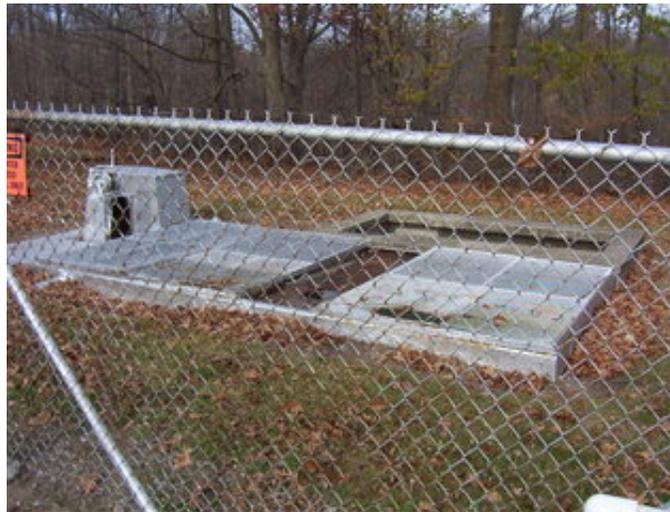
Q. Sewage System

Rating: 3 Needs Replacement

Recommendations: Provide for one new on-site treatment plant on site to serve both buildings. Provide for the removal of the two existing plants as well.

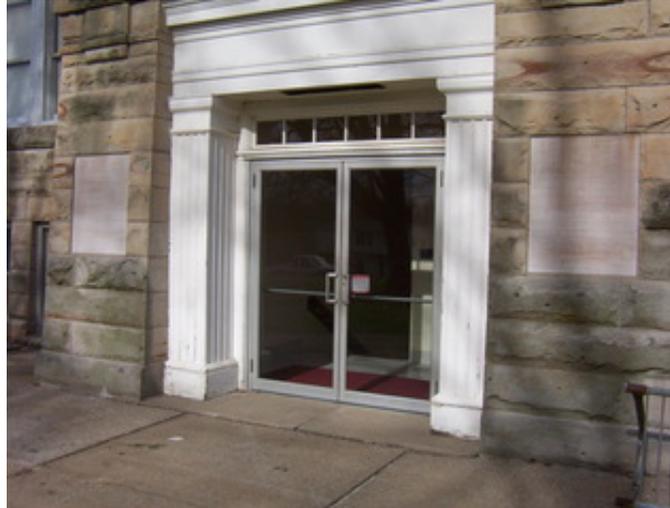
S. Exterior Doors

Description: The building's exterior doors were noted as being thermally inefficient.

Rating: 3 Needs Replacement

Recommendations: Provide for all new thermally rated doors.

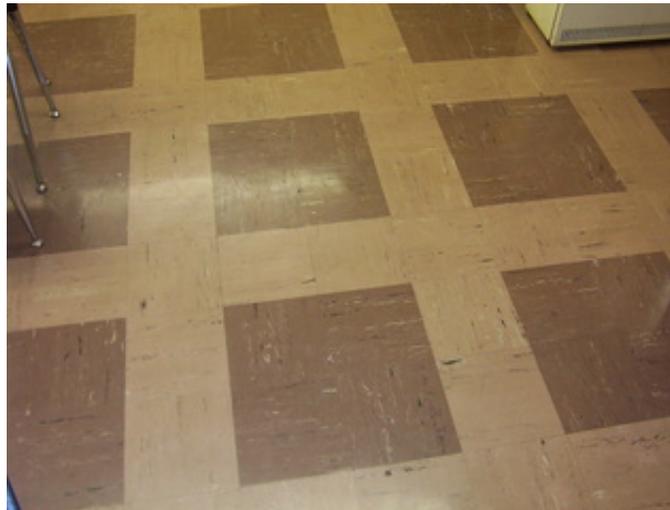
T. Hazardous Material

Rating: 3 Needs Replacement

Recommendations: Provide for the full removal of all remaining asbestos containing materials.

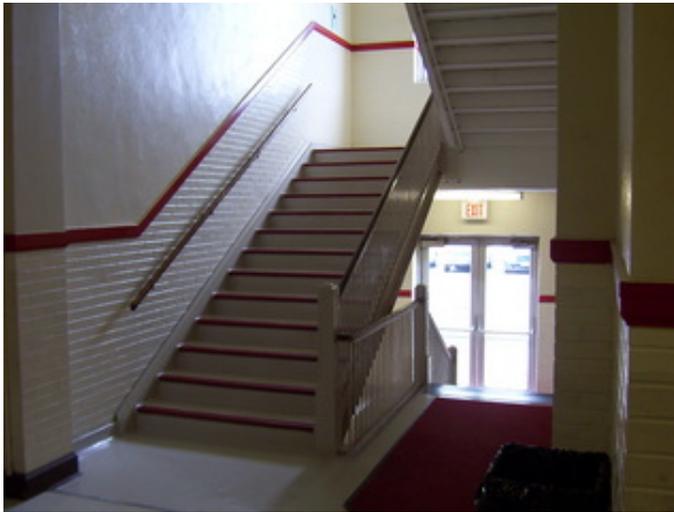
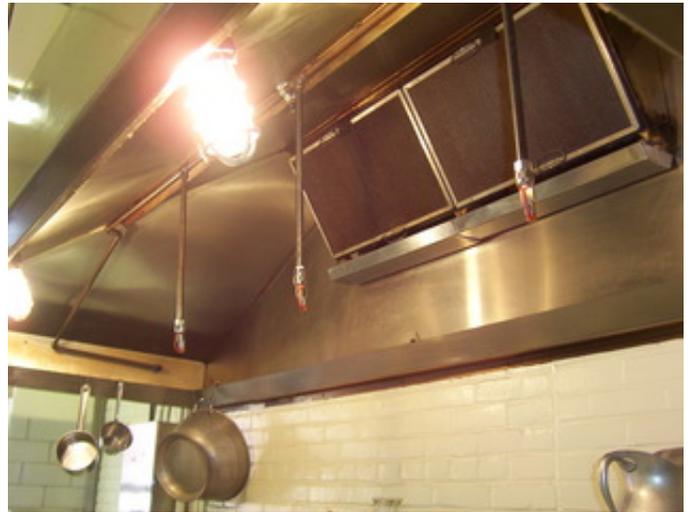
U. Life Safety

Rating: 3 Needs Replacement

Recommendations: Provide for fully sprinklered buildings and fire rated stair enclosures.

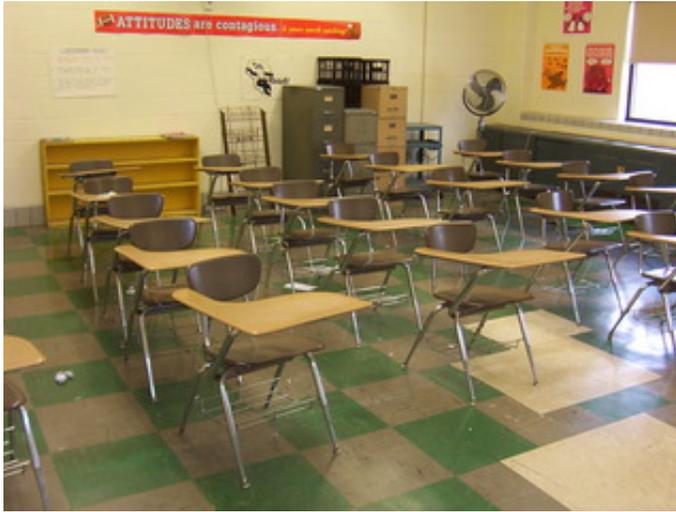
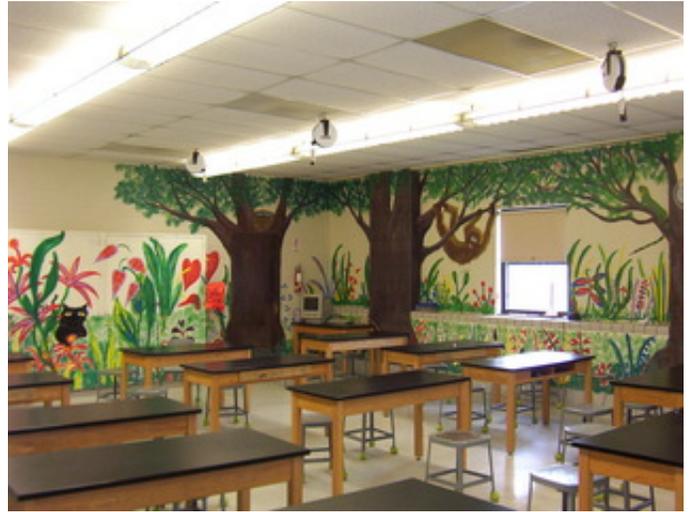
V. Loose Furnishings

Description: Furniture conditions varied throughout both buildings. More upgrading is required.

Rating: 3 Needs Replacement

Recommendations: Provide for further furniture upgrades based on the rating given from item 6.17 of the attached CEFPI (rating was a 4).

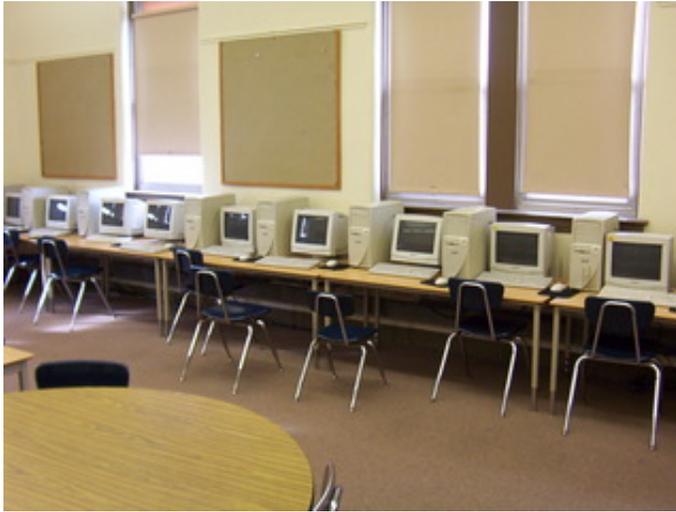
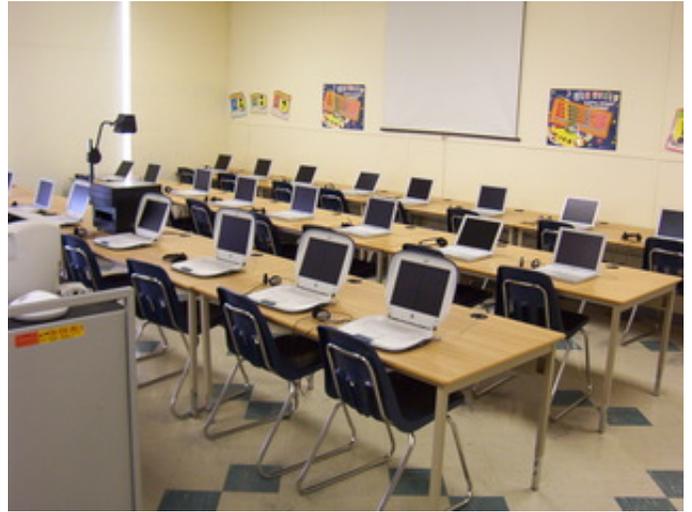
Rating: 3 Needs Replacement

Recommendations: Provide for a full NON-OSDM compliant upgrade for the building's technology systems.
